## Four- Point Inspection Report

Date of inspection:	August 20, 2018
Property's Address:	14693 Martin Drive
Property's City, State, Zip Code:	Fort Myers, Florida 33908
Type of home:	Single Family Detached
Type of construction:	Concrete Block and Wood Frame
Type of foundation:	Concrete Slab
Number of stories:	1
Approximate square feet:	2,325 Sq. Ft.
Approximate total living area:	1,748 Sq. Ft.
Approximate age of home:	1956
Client/owner's name:	Lori Weiss
Insurance company/policy number:	Unknown
Inspector's name:	Christian White
Florida Home Inspectors License number:	HI266
Inspector's signature:	<i>Christian B. White</i>
Inspector's company name:	Safeguard Inspectors LLC
Inspector's address:	1217 Cape Coral Pkwy E. Unit 100
Inspector's city, state, zip code:	Cape Coral, FL 33904
Inspector's email address:	<a href="mailto:Christian@safeguardinspectors.com">Christian@safeguardinspectors.com</a>
Inspector's phone number:	(239) 898-6241

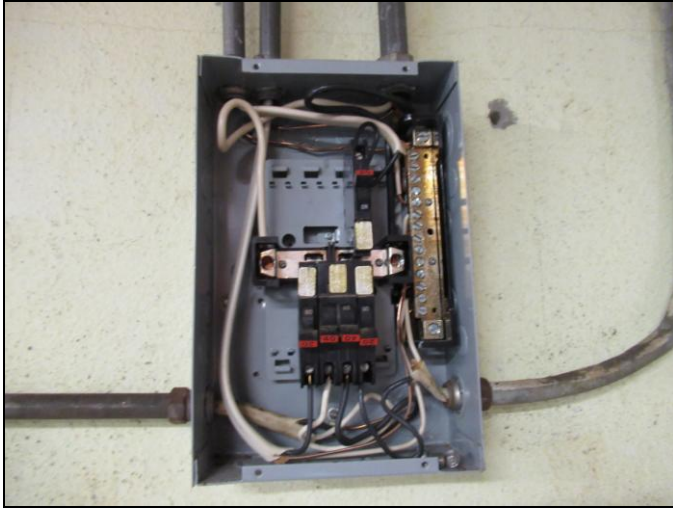
Subject Secondary Distribution Panel Off

<p>Are there any deficiencies which need correction? If so, explain.</p>	<ul style="list-style-type: none"> <li>• There is a federal pacific secondary electrical panel.</li> <li>• Loose outlets were observed.</li> <li>• A damaged electrical outlet was observed.</li> <li>• Main electrical ground is not properly secured.</li> <li>• Exterior wiring was observed to have damaged protective conduit.</li> <li>• An electrical switch is not installed in a protective box.</li> <li>• An active un-terminated electrical wire was observed.</li> <li>• The roofing was deteriorated in multiple locations.</li> <li>• Some roof leaking was suspected.</li> <li>• The air conditioning and heating systems were not working as intended.</li> <li>• The water pump that pressurizes the home was not working as intended.</li> <li>• The water heater is deteriorated.</li> </ul>
<p>When will the deficiencies be corrected? Please provide an approximate date of completion.</p>	Unknown
