INSPECTION REPORT

Report Number
0818201

14693 Martin Drive
Fort Myers, Florida
33908

Inspection Date **Monday, August 20, 2018**

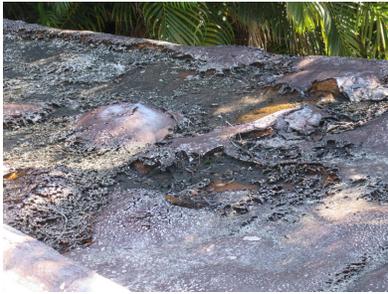
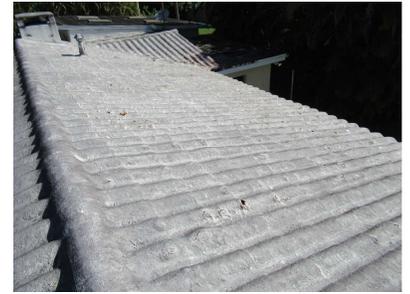
2

LOCATION: Throughout **SYSTEM:** Roof

CONDITION: Roofing is old

RECOMMENDED ACTION: Consult Licensed Roofing Specialist, consider replacing

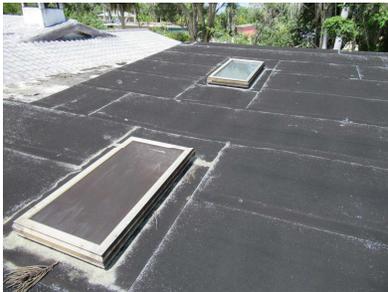
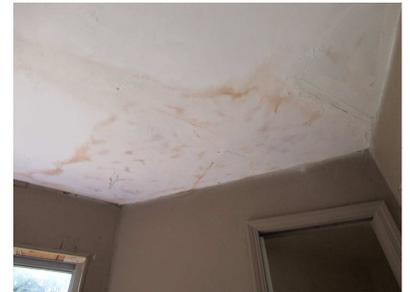
3

LOCATION: Left Building Addition **SYSTEM:** Roof

CONDITION: Asphalt roll roofing is old

RECOMMENDED ACTION: Consult Licensed Roofing Specialist; consider replacing

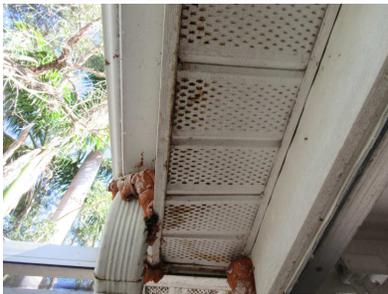
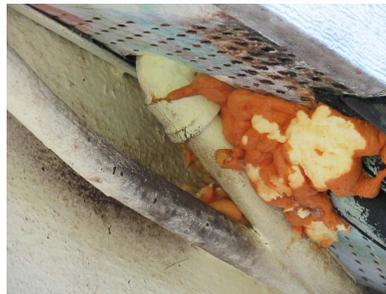
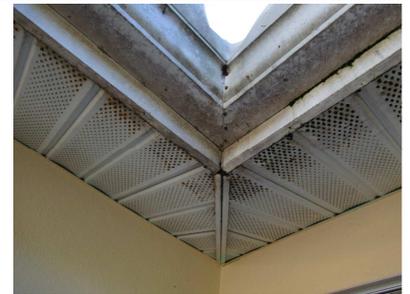
4

LOCATION: Roof, Multiple Locations **SYSTEM:** Roof

CONDITION: Staining on the soffit was observed

RECOMMENDED ACTION: Consult Specialist

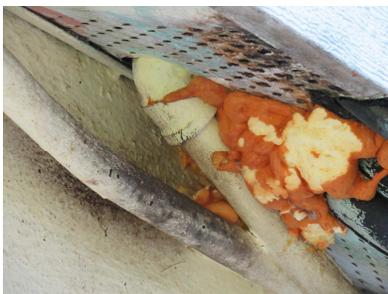
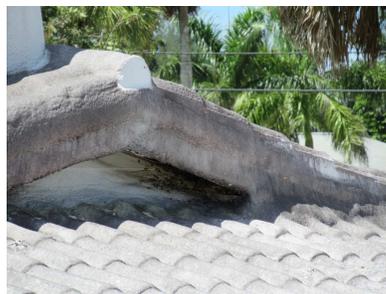
5

LOCATION: Roof **SYSTEM:** Roof

CONDITION: Soffit has areas of potential pest entry

RECOMMENDED ACTION: Repair

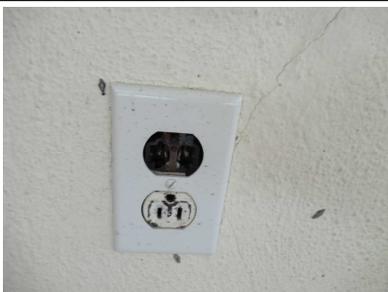
6

LOCATION: A Few Locations **SYSTEM:** Electrical

CONDITION: An exterior outlet as installed is not in a weather tight box

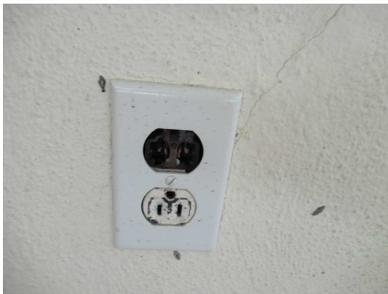
7

**LOCATION:** Exterior Left **SYSTEM:** Electrical**CONDITION:** Electrical outlet is damaged**EXPLANATION:** An electrical outlet is observed to be damaged. The usual cause is due to impact or other forms of mechanical action to fracture the insulating body of the outlet.**IMPACT/CONSEQUENCES:** An outlet that has been damaged may result in the internal contacts not being secured as required, and the risk of short circuiting and arcing is now possible. Damaged outlets should be considered a safety hazard and should be immediately replaced.**RECOMMENDED ACTION:** Replace

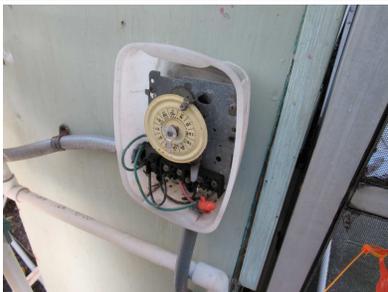
9

**LOCATION:** Exterior Left **SYSTEM:** Electrical**CONDITION:** Switch as installed is not in a weather tight box**EXPLANATION:** Switches installed on outdoor locations or locations where water can come in contact with the switch. The switch should be installed in a weather tight box with a weather tight cover. The box is damaged and there is no cover installed.**IMPACT/CONSEQUENCES:** A switch not installed in a weather tight box, and when in an location where water can enter the box, is subject to shorting, damage, and deterioration. Switches displaying damage or deterioration should be immediately replaced and a suitable box and cover installed.**RECOMMENDED ACTION:** Replace

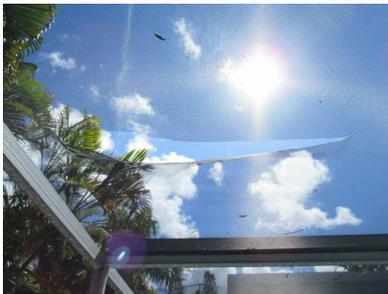
10

LOCATION: A Few Locations **SYSTEM:** Exterior

CONDITION: Exterior has a damaged screen

RECOMMENDED ACTION: Repair

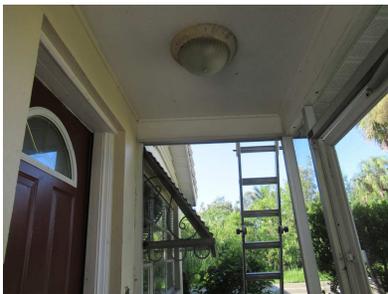
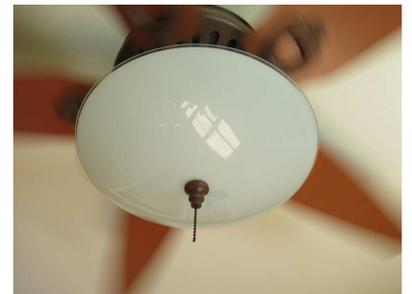
11

LOCATION: A Few Locations **SYSTEM:** Electrical

CONDITION: Electrical fixture doesn't work

RECOMMENDED ACTION: Repair

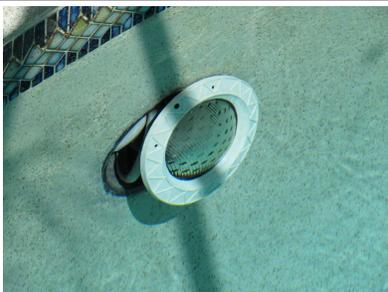
12

LOCATION: Exterior Left **SYSTEM:** Electrical

CONDITION: Pool light doesn't work

RECOMMENDED ACTION: Repair

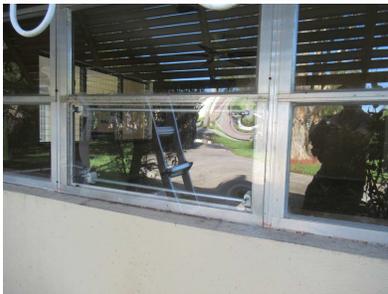
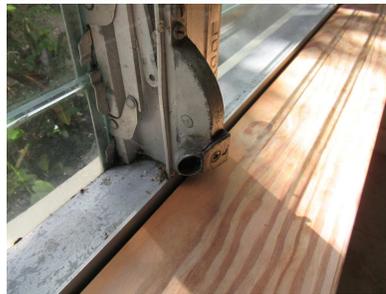
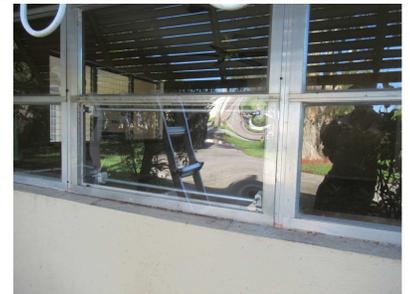
13

LOCATION: Throughout **SYSTEM:** Exterior

CONDITION: Window unit is damaged; performance affecting

RECOMMENDED ACTION: Repair or replace

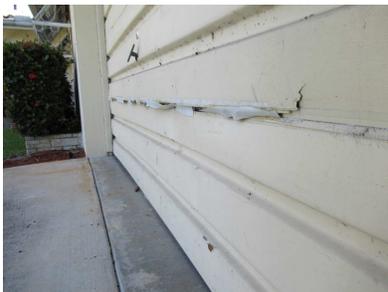
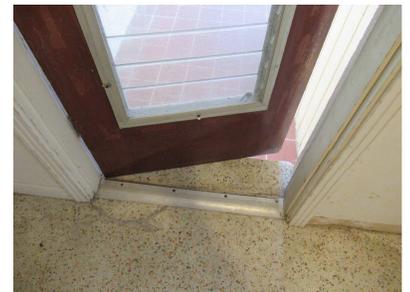
14

LOCATION: Multiple Locations **SYSTEM:** Exterior

CONDITION: Exterior door is damaged; performance affecting

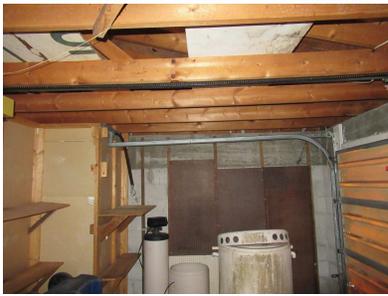
15

**LOCATION:** Garage **SYSTEM:** Exterior**CONDITION:** Garage door has loose or damaged spring.**EXPLANATION:** Hardware required for proper operation and function of the door is damaged or loose. A primary function of the exterior door is to operate in a manner that ensures the door will open and close with relative ease, and with the capability to restrict forced entry. The door fails to stay in the open position.**IMPACT/CONSEQUENCES:** A priority consideration for exterior doors is that they meet each of its key operability and performance requirements. Failure to take corrective action may result in a safety issue. Immediate repair/replacement of affected door components should be considered as a priority action. A qualified door/window contractor may be required to implement action needs.**RECOMMENDED ACTION:** Repair

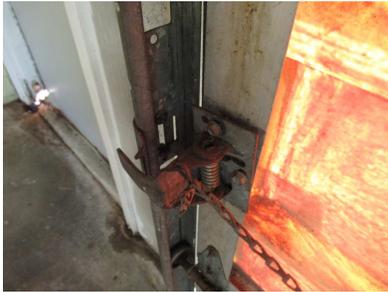
16

**LOCATION:** Exterior Rear Garage Door **SYSTEM:** Exterior**CONDITION:** Exterior door has damaged door latch hardware**EXPLANATION:** Hardware required for latching or locking the exterior door is damaged. Absence of functional hardware impairs security at this entry door. The door will not stay locked.**IMPACT/CONSEQUENCES:** Damage of this hardware impairs security at this entry door, and exposes the home to the risk of entry by intruders. This is a safety concern. Immediate action is required to repair or install suitable hardware to ensure the door can be securely latched and locked.**RECOMMENDED ACTION:** Repair, replace, or install as required

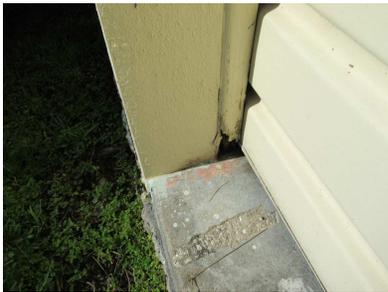
17

**LOCATION:** A Few Locations **SYSTEM:** Exterior**CONDITION:** Exterior door frame/sill is rotted**EXPLANATION:** Deterioration of the door frame is noted, with rot observed.**IMPACT/CONSEQUENCES:** Wood rot is an indication of deterioration of wood components of the door that have been exposed to the effects of water and weather. Failure to correct this condition increases the risk of water infiltration and damage to structural components and interior finishes. Replacing the door unit should be considered.**RECOMMENDED ACTION:** Repair, consider replacing

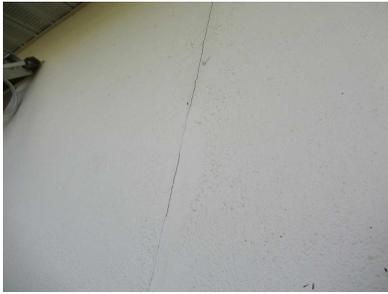
18

LOCATION: A Few Locations **SYSTEM:** Exterior

CONDITION: Cracks in exterior stucco wall surfaces

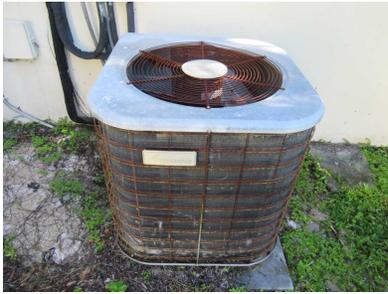
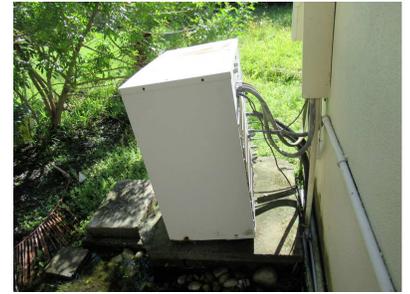
20

LOCATION: Throughout, Both Systems **SYSTEM:** Heating/Cooling

CONDITION: Air conditioner failed to operate when inspected

RECOMMENDED ACTION: Consult Specialist, Consider Replacing

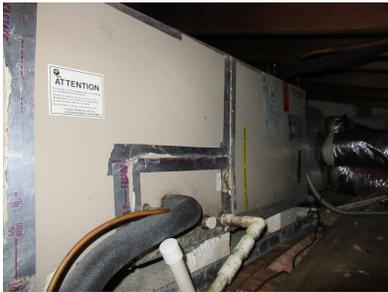
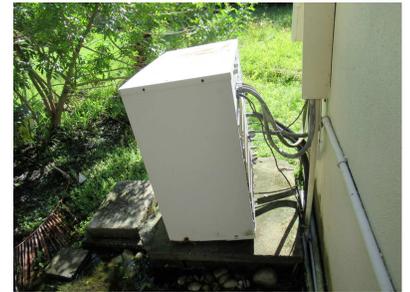
21

LOCATION: Throughout **SYSTEM:** Heating/Cooling

CONDITION: Air conditioner and/or air handler is older than half of expected life

RECOMMENDED ACTION: Consult Specialist, Consider Replacing

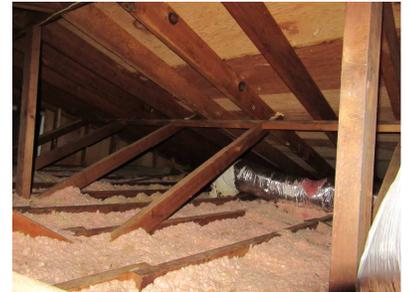
22

LOCATION: Attic **SYSTEM:** Interior

CONDITION: Evidence of pest entry to roof space

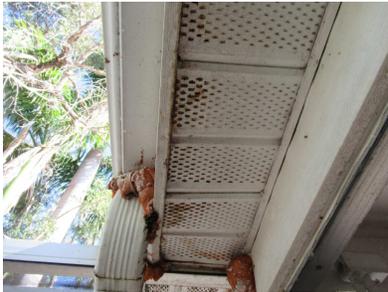
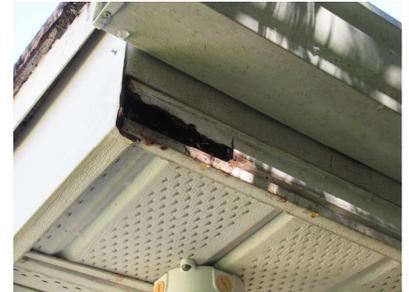
24

LOCATION: A Few Locations **SYSTEM:** Roof

CONDITION: Fascia is deteriorated

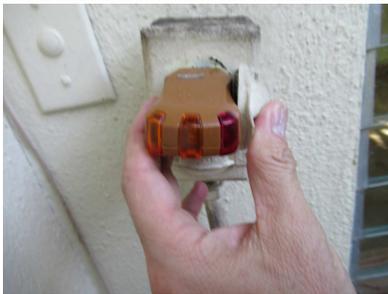
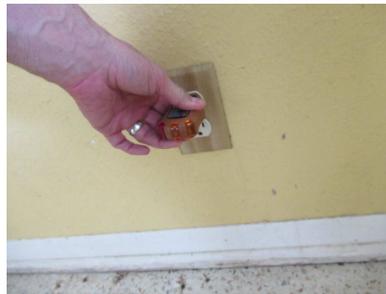
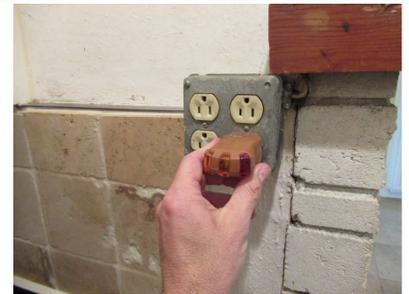
27

LOCATION: A Few Locations **SYSTEM:** Electrical

CONDITION: Electrical outlet does not work

RECOMMENDED ACTION: Repair

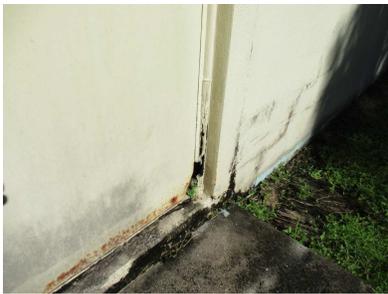
28

LOCATION: Multiple Locations **SYSTEM:** Exterior

CONDITION: Paint is chipping

RECOMMENDED ACTION: Review

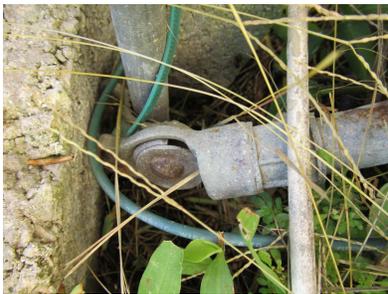
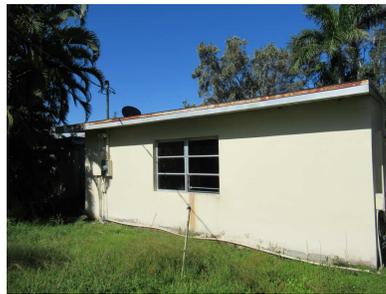
29

LOCATION: Exterior Back **SYSTEM:** Electrical

CONDITION: The primary electrical system ground is not securely attached

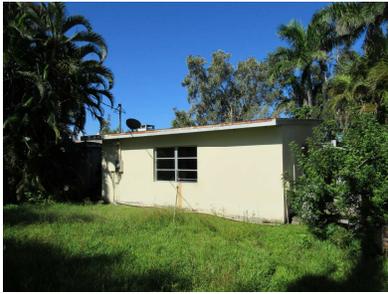
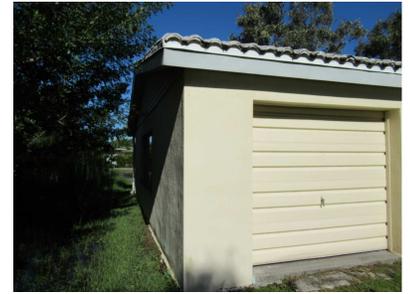
30

LOCATION: Exterior **SYSTEM:** Exterior

CONDITION: Poor yard grading and/or drainage

RECOMMENDED ACTION: Consult Specialist

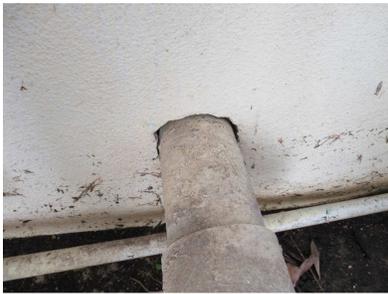
31

LOCATION: Exterior Left Side **SYSTEM:** Exterior

CONDITION: Hole in wall is not sealed

RECOMMENDED ACTION: Repair

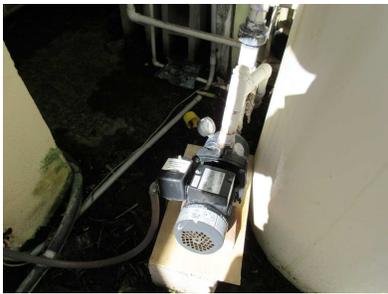
32

LOCATION: Exterior Left **SYSTEM:** Plumbing

CONDITION: Pump does not work

RECOMMENDED ACTION: Repair

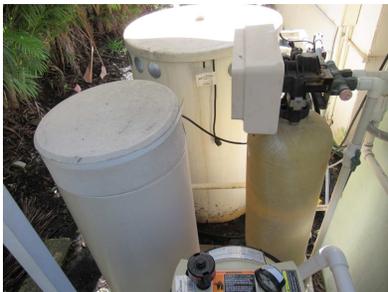
33

LOCATION: Exterior Left **SYSTEM:** Plumbing

CONDITION: Well equipment is old

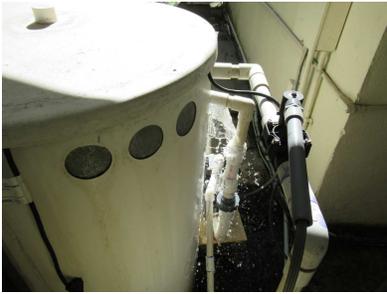
34

**LOCATION:** Exterior Left **SYSTEM:** Plumbing**CONDITION:** Holding tank float switch is not working correctly**EXPLANATION:** At the time of inspection the float switch, in the holding tank, did not work as intended. Water was observed to be overflowing from the tank.**IMPACT/CONSEQUENCES:** Water will continuously pour from the holding tank.**RECOMMENDED ACTION:** Repair or Replace

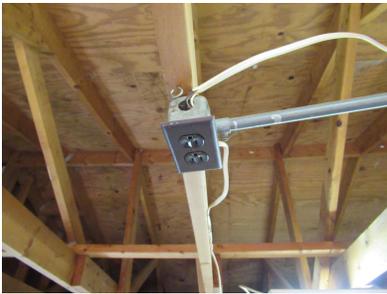
36

**LOCATION:** Garage **SYSTEM:** Electrical**CONDITION:** Missing protection of wires at boxes or panels**EXPLANATION:** Wiring entering protective boxes and panels requires mechanical protection and protection from sharp edges.**IMPACT/CONSEQUENCES:** Bushings or other suitable means of protecting wires entering boxes and panels is required to secure the wire and reduce the risk of damage to the wire from sharp edges at the point where the wire penetrated the box. Missing protection should be added to protect the wires. Where damage is observed to the wire insulation or conductors, the wire should be repaired or replaced.**RECOMMENDED ACTION:** Repair

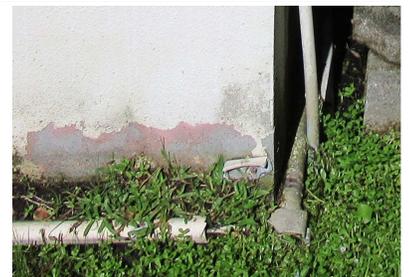
37

**LOCATION:** A Few Locations **SYSTEM:** Electrical**CONDITION:** Exterior wiring conduit damaged**EXPLANATION:** An exterior protective conduit was observed to be damaged at the time of inspection.**IMPACT/CONSEQUENCES:** The damaged conduit leaves the wire exposed to possible damage. Damaged wiring is a safety hazard to the home and its occupants.**RECOMMENDED ACTION:** Repair

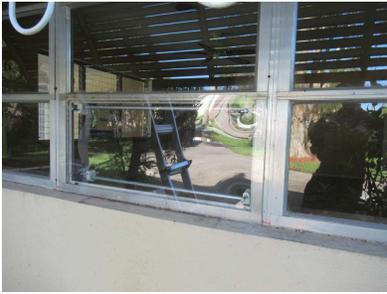
38

LOCATION: Throughout **SYSTEM:** Exterior

CONDITION: Exterior window has a missing screen

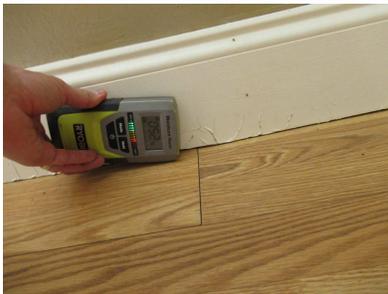
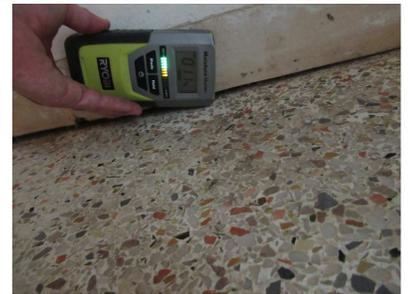
40

LOCATION: Throughout, The original home **SYSTEM:** Interior

CONDITION: Mold or fungus is visible on interior surfaces

RECOMMENDED ACTION: Consult Licensed Mold Specialist

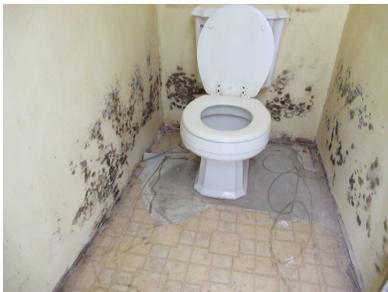
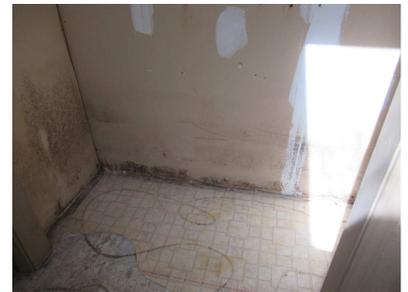
41

LOCATION: Wood Frame Addition, Master Bedroom Area **SYSTEM:** Interior

CONDITION: Mold or fungus is visible on interior surfaces

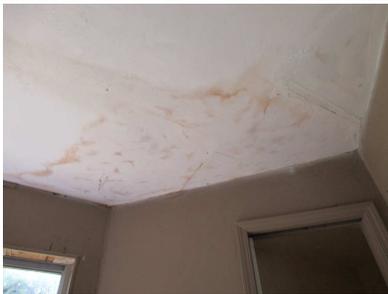
42

LOCATION: Master Bedroom **SYSTEM:** Interior

CONDITION: Mold or fungi is visible on interior surfaces

RECOMMENDED ACTION: Consult Licensed Mold Specialist

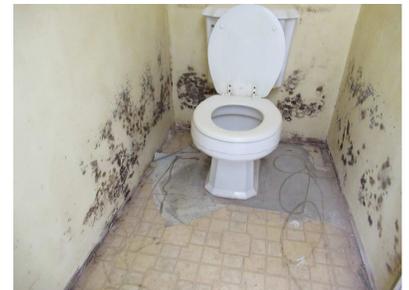
43

LOCATION: Multiple Locations **SYSTEM:** Interior

CONDITION: Physical impact damage noted in wall surface finish.

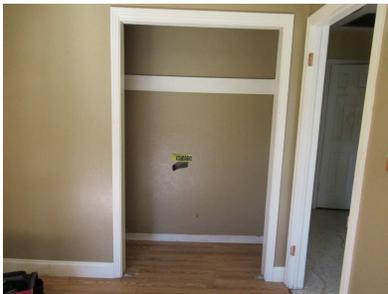
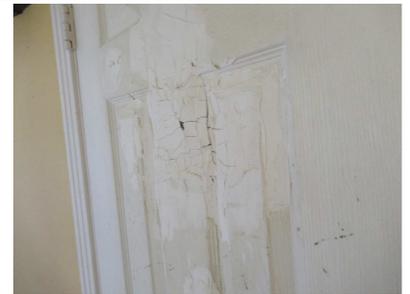
44

LOCATION: Multiple Locations **SYSTEM:** Interior

CONDITION: Interior door is missing

RECOMMENDED ACTION: Review

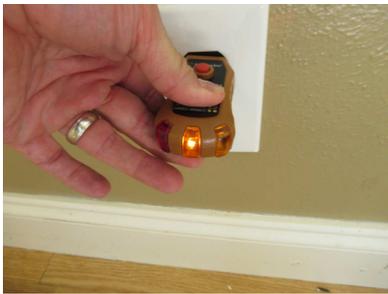
45

LOCATION: Multiple Locations **SYSTEM:** Electrical

CONDITION: Receptacle installed with ground connection not found

RECOMMENDED ACTION: Consult Licensed Electrical Specialist

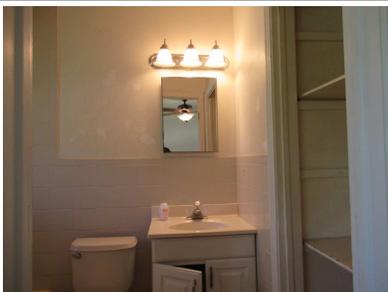
46

LOCATION: Multiple Locations **SYSTEM:** Electrical

CONDITION: Ground fault protection (GFCI) for an outlet is recommended

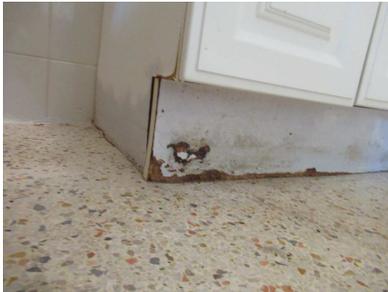
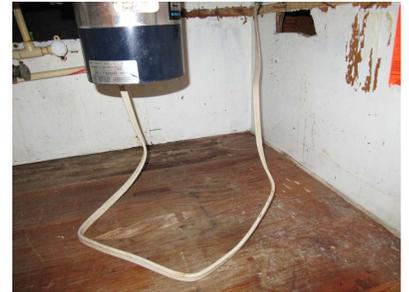
47

LOCATION: Throughout **SYSTEM:** Interior
CONDITION: Mold or fungus is visible in cabinets

EXPLANATION: Mold or fungus in cabinets is an indication of a moisture issue at the cabinet.

RECOMMENDED ACTION: Review

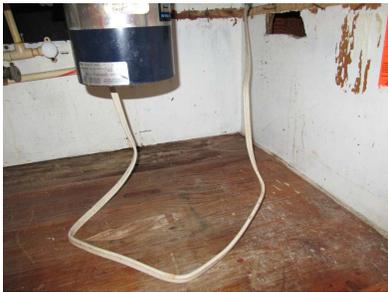
48

LOCATION: Kitchen **SYSTEM:** Interior
CONDITION: Garbage disposal is not working.

EXPLANATION: At the time of the inspection the garbage disposal did not function correctly or function at all.

RECOMMENDED ACTION: Review

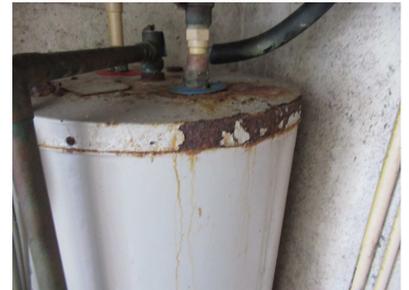
49

LOCATION: Utility Closet **SYSTEM:** Plumbing

CONDITION: Water tank is old

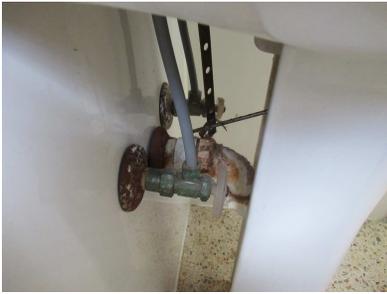
50

LOCATION: Throughout **SYSTEM:** Plumbing

CONDITION: Shutoff valve is deteriorated

RECOMMENDED ACTION: Replace

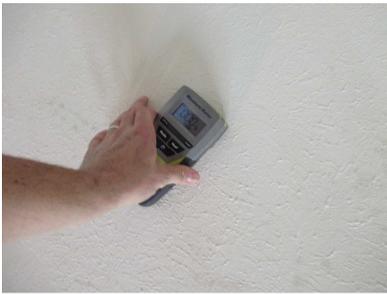
51

LOCATION: Main House Structure, Multiple Locations **SYSTEM:** Interior

CONDITION: Water stains visible on interior ceiling surfaces

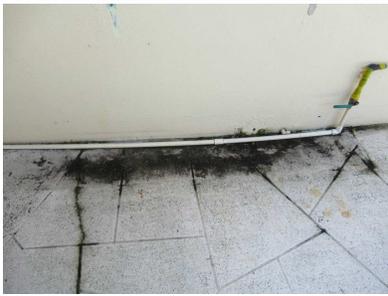
53

**LOCATION:** Exterior **SYSTEM:** Exterior**CONDITION:** Patio has settled**EXPLANATION:** Settlement is observed at the patio. Settlement of the patio may be due to poor soil or compaction issues and poor drainage.**IMPACT/CONSEQUENCES:** This condition may impair drainage. Settlement can result in water ponding on the patio, which may promote deterioration of the patio over time. Uneven surfaces can present the risk of trip hazards.**RECOMMENDED ACTION:** Review

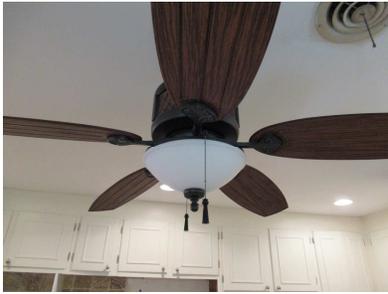
56

**LOCATION:** Kitchen **SYSTEM:** Electrical**CONDITION:** Electrical fixture flickers**EXPLANATION:** An illumination fixture is observed to be flickering at the time of inspection. The fan also did not appear to be working properly.**IMPACT/CONSEQUENCES:** A flickering fixture may indicate that the fixture, related switches, or associated wiring may be loose or defective. In some cases, this may present a safety issue. If the fixture remains inoperative after verifying that the bulb(s) is/are correctly installed, then investigation by an electrician is recommended.**RECOMMENDED ACTION:** Consult Specialist

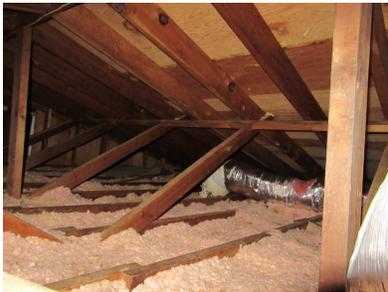
58

**LOCATION:** Attic **SYSTEM:** Insulation/Ventilation**CONDITION:** Insulation is compressed**EXPLANATION:** Insulation is observed to be disturbed and compressed in such a manner that the insulation value has been reduced at some locations.**IMPACT/CONSEQUENCES:** Insulation that has been disturbed and compressed can result in greater than intended heat loss or gain, and possibly result in condensation issues in the affected area. Restoring the condition (density) of the insulation, and possibly installing additional insulation, is suggested.**RECOMMENDED ACTION:** Adjust

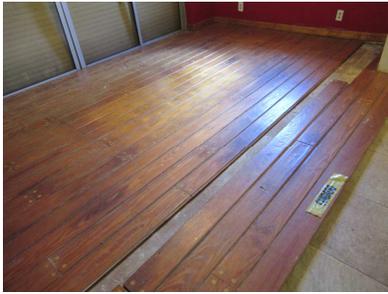
60

**LOCATION:** Kitchen **SYSTEM:** Interior**CONDITION:** Floor cover is damaged**EXPLANATION:** Damage is noted in the floor cover due to wear, impact, abrasion, scratches, stains, etc., that affect the cosmetic appearance of the floor cover.**IMPACT/CONSEQUENCES:** Provided the floor cover is otherwise sound and the condition does not present a trip hazard, damage to the floor cover is generally considered as visually detracting. Should the condition present a trip hazard, corrective action should be taken to remove the hazard, either by a repair at the location of the hazard or by replacing the floor cover. Otherwise, the decision to change the floor cover due to damage is generally discretionary, based on aesthetic and use factors.**RECOMMENDED ACTION:** Repair

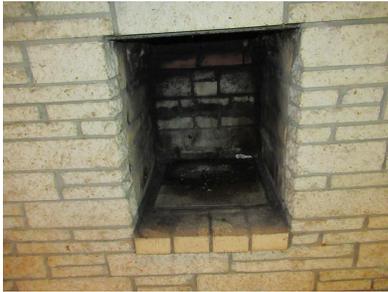
61

**LOCATION:** Kitchen **SYSTEM:** Interior**CONDITION:** Fireplace has missing damper**EXPLANATION:** The fireplace damper provides control in drafting for the fireplace during operation. The fireplace chimney cannot be closed off from drafts when the fireplace is not in use.**IMPACT/CONSEQUENCES:** A missing damper results in absence of the ability to close off the chimney when the fireplace is not in use. A missing damper will result in heat loss in the home due to drafts, and this heat loss can be quite significant. An missing damper on a fireplace can also result in unwanted "guests" entering the home, such as birds, bats, insects, and rodents. The damper should be replaced to ensure operation of this device as intended. A fireplace specialist may be required to perform repairs.**RECOMMENDED ACTION:** Repair
