INSPECTION REPORT

Report Number
0818201

14693 Martin Drive
Fort Myers, Florida
33908

Inspection Date **Monday, August 20, 2018**

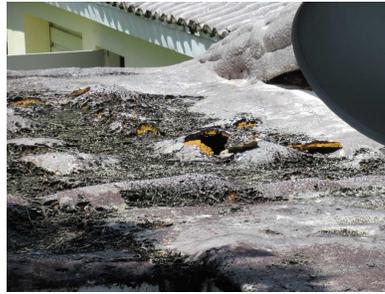
2

-
- 1 **CONDITION:** Roofing is old
OBSERVED AT LOCATION(s): Throughout
EXPLANATION & IMPACT: *The foam sealed roofing is deteriorated and appears to be beyond it's useful life. A licensed roofing specialist should be consulted. The foam is typically applied when the roofing surface is past it's useful life. Now, even the foam is deteriorated. As a result of a review of the roof covering, the overall condition is such that the roof is deemed to be at or beyond its limits of its serviceable life. Extensive indicators of age are noted. Consideration should be given to replacing the roof covering; the timing to ultimate failure of the roof covering in preventing water infiltration is unpredictable. Failing to replace the roof covering may result in damage to the structure and contents of the home.*
RECOMMENDED ACTION: Consult Licensed Roofing Specialist, consider replacing
-

LOCATION: Throughout **SYSTEM:** Roof

CONDITION: Roofing is old

RECOMMENDED ACTION: Consult Licensed Roofing Specialist, consider replacing

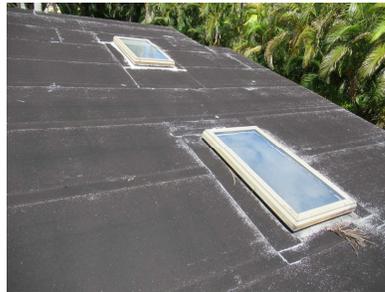
3

- 2 **CONDITION:** Asphalt roll roofing is old
OBSERVED AT LOCATION(s): Left Building Addition
EXPLANATION & IMPACT: *The shingle roof surface is displaying indicators that the protective roof covering is at or near the end of its service life. Significant areas of roof leakage is suspected. As a result of a review of the roof covering, the overall condition is such that the roof is deemed to be at or beyond its limits of its serviceable life. Extensive indicators of age are noted. Consideration should be given to replacing the roof covering; the ultimate failure of the roof covering in preventing water infiltration is unpredictable. Failing to replace the roof covering may result in damage to the structure and contents of the home.*
RECOMMENDED ACTION: Consult Licensed Roofing Specialist; consider replacing
-

LOCATION: Left Building Addition **SYSTEM:** Roof

CONDITION: Asphalt roll roofing is old

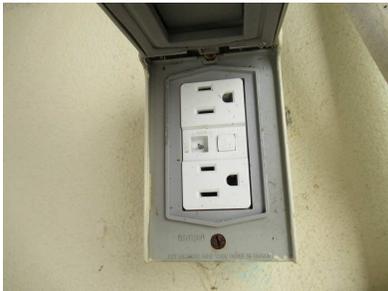
8

**LOCATION:** Exterior Left **SYSTEM:** Electrical**CONDITION:** Ground-fault circuit interrupter (GFCI) fails to trip or is miswired**EXPLANATION:** The Ground Fault Circuit Interrupt (GFCI) outlet as tested by an independent device/tester does not function as intended.**IMPACT/CONSEQUENCES:** The GFCI receptacle is provided as a safety device in locations where the presence of water increases the risk of electrical shock. Failure to correct this deficiency may result in serious injury and possibly death from electrical shocks should the device not operate when needed. Immediate repair or replacement is recommended.**RECOMMENDED ACTION:** Repair

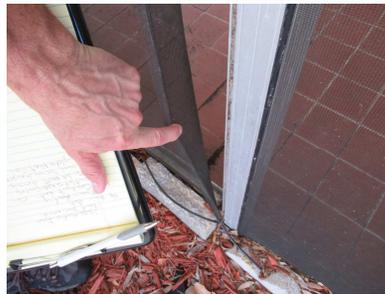
10

LOCATION: A Few Locations **SYSTEM:** Exterior

CONDITION: Exterior has a damaged screen

RECOMMENDED ACTION: Repair

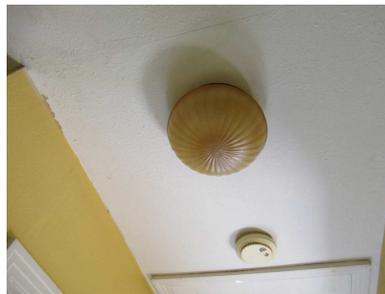
11

LOCATION: A Few Locations **SYSTEM:** Electrical

CONDITION: Electrical fixture doesn't work

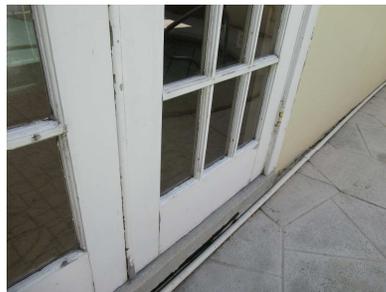
14

LOCATION: Multiple Locations **SYSTEM:** Exterior

CONDITION: Exterior door is damaged; performance affecting

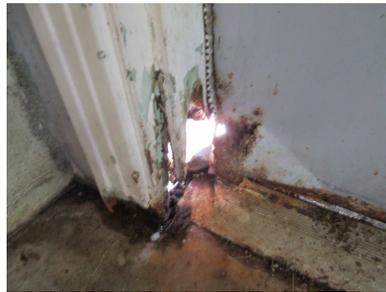
17

**LOCATION:** A Few Locations **SYSTEM:** Exterior**CONDITION:** Exterior door frame/sill is rotted**EXPLANATION:** Deterioration of the door frame is noted, with rot observed.**IMPACT/CONSEQUENCES:** Wood rot is an indication of deterioration of wood components of the door that have been exposed to the effects of water and weather. Failure to correct this condition increases the risk of water infiltration and damage to structural components and interior finishes. Replacing the door unit should be considered.**RECOMMENDED ACTION:** Repair, consider replacing

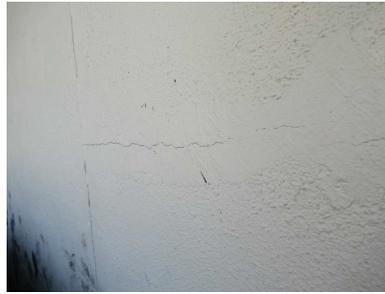
18

LOCATION: A Few Locations **SYSTEM:** Exterior

CONDITION: Cracks in exterior stucco wall surfaces

RECOMMENDED ACTION: Review

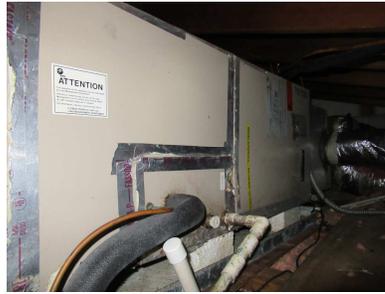
20

LOCATION: Throughout, Both Systems **SYSTEM:** Heating/Cooling

CONDITION: Air conditioner failed to operate when inspected

RECOMMENDED ACTION: Consult Specialist, Consider Replacing

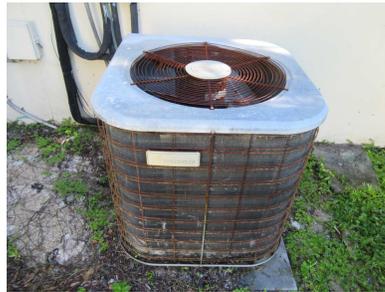
21

LOCATION: Throughout **SYSTEM:** Heating/Cooling

CONDITION: Air conditioner and/or air handler is older than half of expected life

RECOMMENDED ACTION: Consult Specialist, Consider Replacing

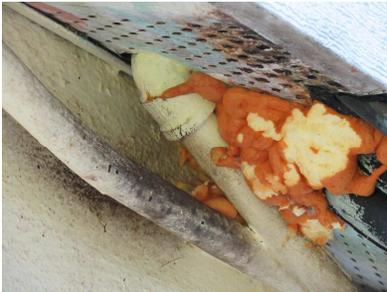
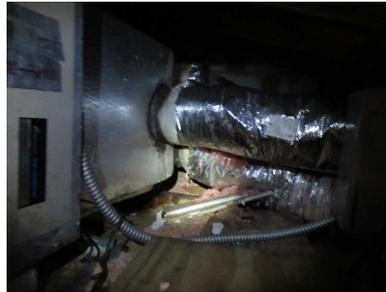
22

LOCATION: Attic **SYSTEM:** Interior

CONDITION: Evidence of pest entry to roof space

RECOMMENDED ACTION: Consult Specialist

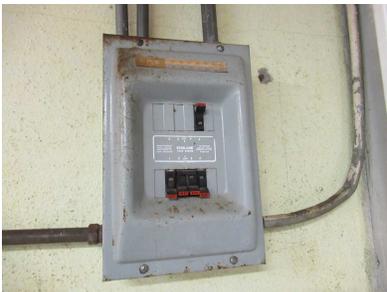
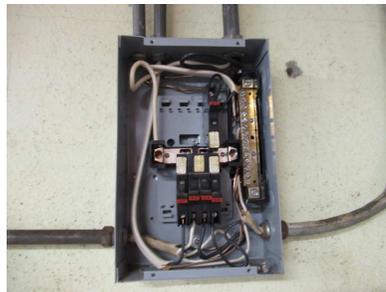
23

LOCATION: Garage **SYSTEM:** Electrical

CONDITION: The electrical panel and electrical breakers are made by Federal Pacific

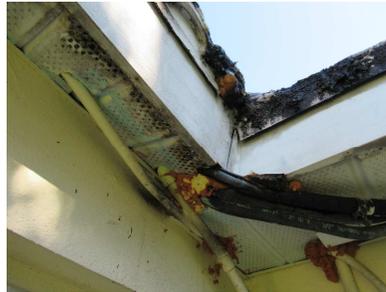
24

LOCATION: A Few Locations **SYSTEM:** Roof

CONDITION: Fascia is deteriorated

RECOMMENDED ACTION: Repair

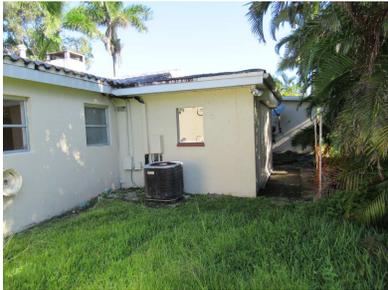
25

LOCATION: Roof **SYSTEM:** Roof

CONDITION: Gutter is damaged

RECOMMENDED ACTION: Repair or replace

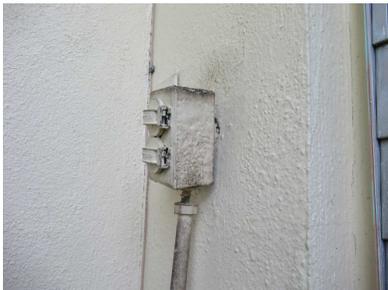
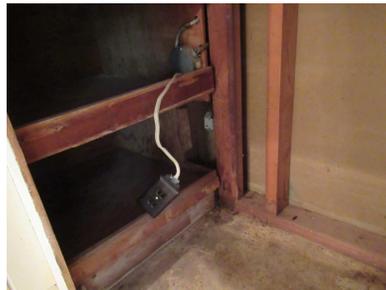
26

LOCATION: Exterior Back and Kitchen **SYSTEM:** Electrical

CONDITION: Electrical box is loose

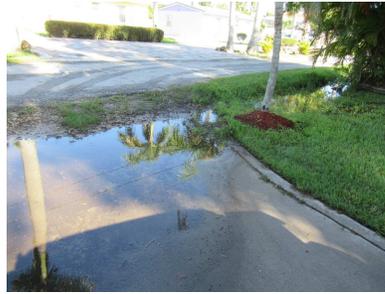
30

LOCATION: Exterior **SYSTEM:** Exterior

CONDITION: Poor yard grading and/or drainage

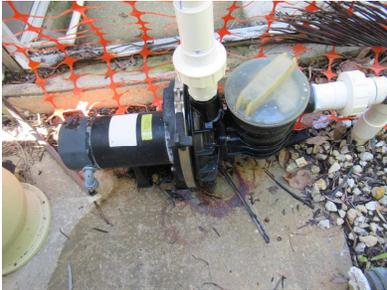
35

**LOCATION:** Exterior Left Side **SYSTEM:** Exterior**CONDITION:** Pool equipment has a leak**EXPLANATION:** At time of inspection the pool equipment was observed to be leaking.**IMPACT/CONSEQUENCES:** A leak may impair the functionality of the equipment.**RECOMMENDED ACTION:** Repair

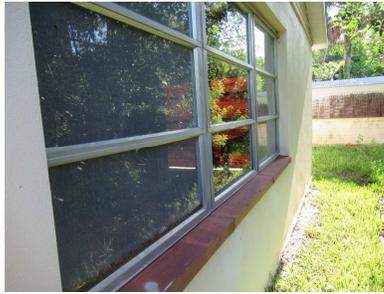
38

LOCATION: Throughout **SYSTEM:** Exterior

CONDITION: Exterior window has a missing screen

RECOMMENDED ACTION: Replace

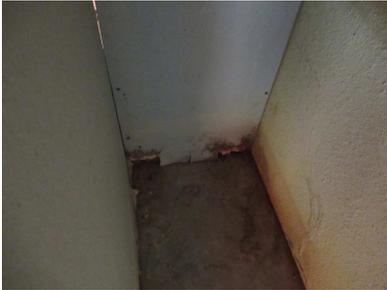
39

LOCATION: Garage **SYSTEM:** Interior

CONDITION: Mold or fungus is visible on interior surfaces

RECOMMENDED ACTION: Consult Licensed Mold Specialist

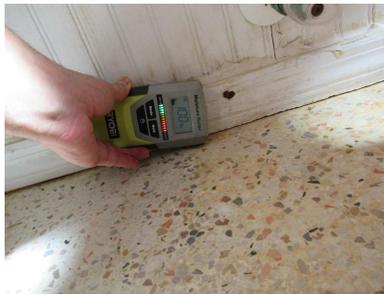
40

LOCATION: Throughout, The original home **SYSTEM:** Interior

CONDITION: Mold or fungus is visible on interior surfaces

RECOMMENDED ACTION: Consult Licensed Mold Specialist

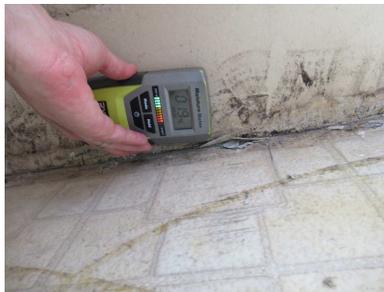
41

LOCATION: Wood Frame Addition, Master Bedroom Area **SYSTEM:** Interior

CONDITION: Mold or fungus is visible on interior surfaces

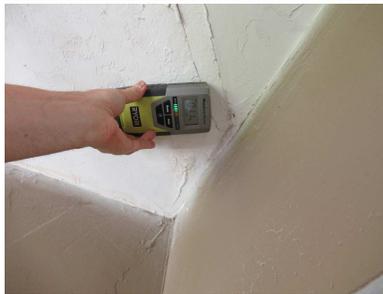
42

LOCATION: Master Bedroom **SYSTEM:** Interior

CONDITION: Mold or fungi is visible on interior surfaces

RECOMMENDED ACTION: Consult Licensed Mold Specialist

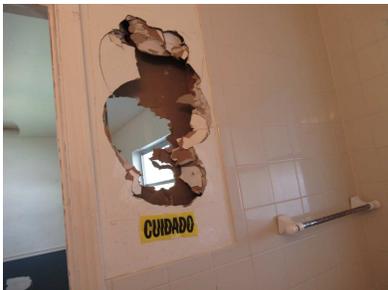
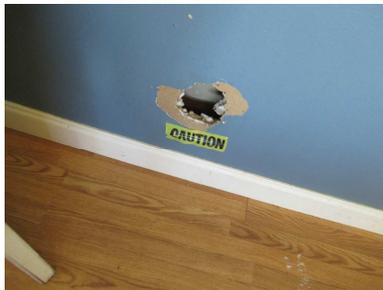
43

LOCATION: Multiple Locations **SYSTEM:** Interior

CONDITION: Physical impact damage noted in wall surface finish.

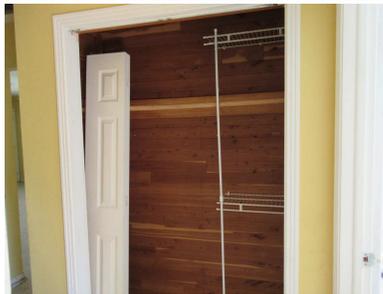
44

LOCATION: Multiple Locations **SYSTEM:** Interior

CONDITION: Interior door is missing

RECOMMENDED ACTION: Review

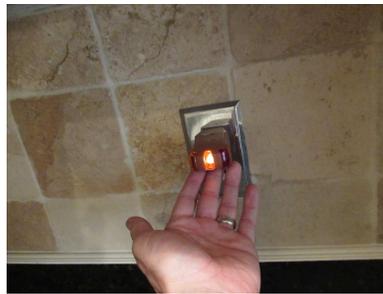
45

LOCATION: Multiple Locations **SYSTEM:** Electrical

CONDITION: Receptacle installed with ground connection not found

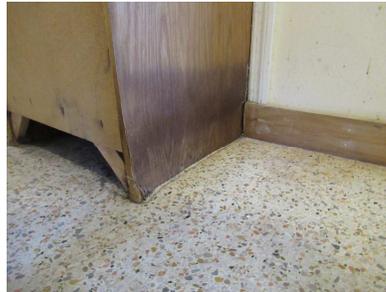
47

LOCATION: Throughout **SYSTEM:** Interior
CONDITION: Mold or fungus is visible in cabinets

EXPLANATION: Mold or fungus in cabinets is an indication of a moisture issue at the cabinet.

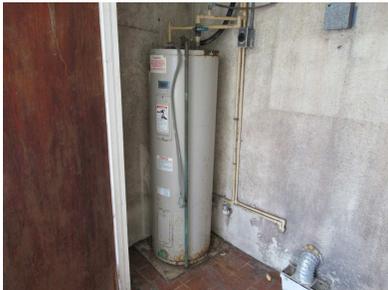
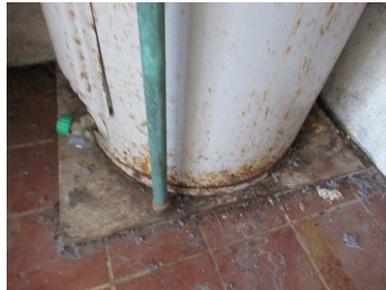
49

LOCATION: Utility Closet **SYSTEM:** Plumbing

CONDITION: Water tank is old

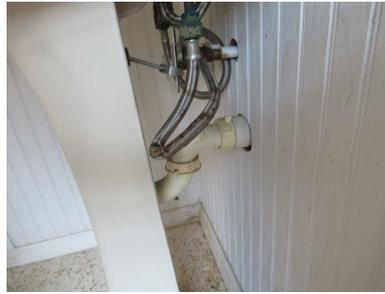
50

LOCATION: Throughout **SYSTEM:** Plumbing

CONDITION: Shutoff valve is deteriorated

RECOMMENDED ACTION: Review

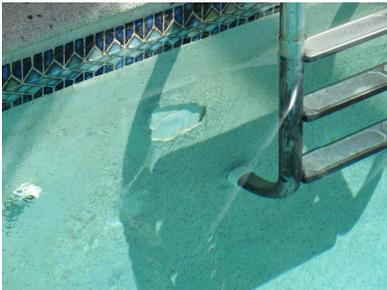
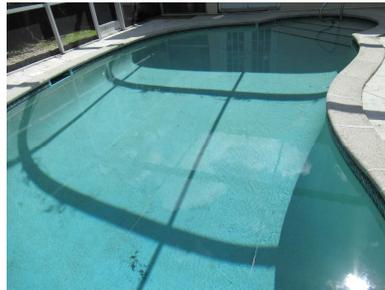
52

LOCATION: Exterior **SYSTEM:** Exterior

CONDITION: Damage to the pool surface.

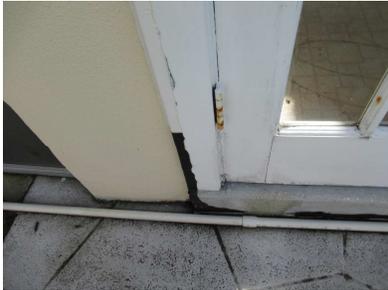
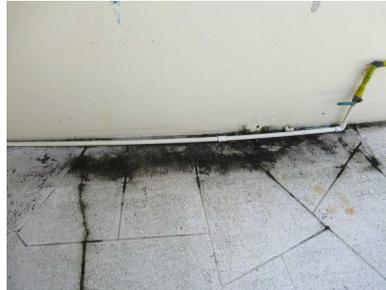
**LOCATION:** Exterior **SYSTEM:** Exterior**CONDITION:** Patio has settled**EXPLANATION:** Settlement is observed at the patio. Settlement of the patio may be due to poor soil or compaction issues and poor drainage.**IMPACT/CONSEQUENCES:** This condition may impair drainage. Settlement can result in water ponding on the patio, which may promote deterioration of the patio over time. Uneven surfaces can present the risk of trip hazards.**RECOMMENDED ACTION:** Review

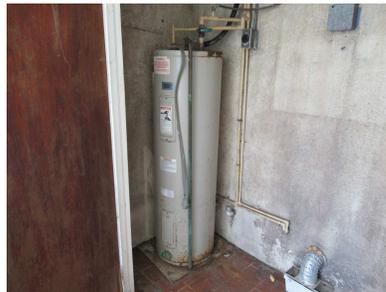
**LOCATION:** Exterior **SYSTEM:** Plumbing**CONDITION:** Water pipes are exposed to damage**EXPLANATION:** A water pipe is noted to be routed in a location vulnerable to damage.**IMPACT/CONSEQUENCES:** Water pipes should be routed in locations where they are not exposed to potential sources of physical damage.**RECOMMENDED ACTION:** Repair

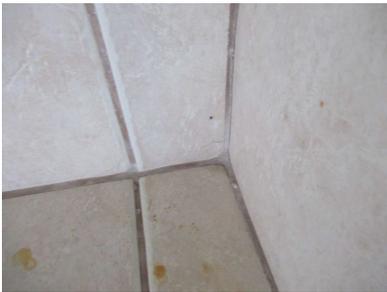
LOCATION: Main Bathroom **SYSTEM:** Plumbing

CONDITION: Bathtub area has missing, damaged, or loose tiles

EXPLANATION: Tiles at the bathtub enclosure are observed to be missing, damaged or loose.

IMPACT/CONSEQUENCES: In addition to being cosmetically detracting, tiles that are missing, loose, or damaged will compromise the effectiveness of the bathtub enclosure in preventing moisture from seeping into walls and floors, and causing damage associated with leaks. Failure to correct tile deficiencies can result in damage and costly repairs.

RECOMMENDED ACTION: Repair
